TBF/TBM Avenger

Walk Around Number 25
squadron/signal publications

By Lou Drendel

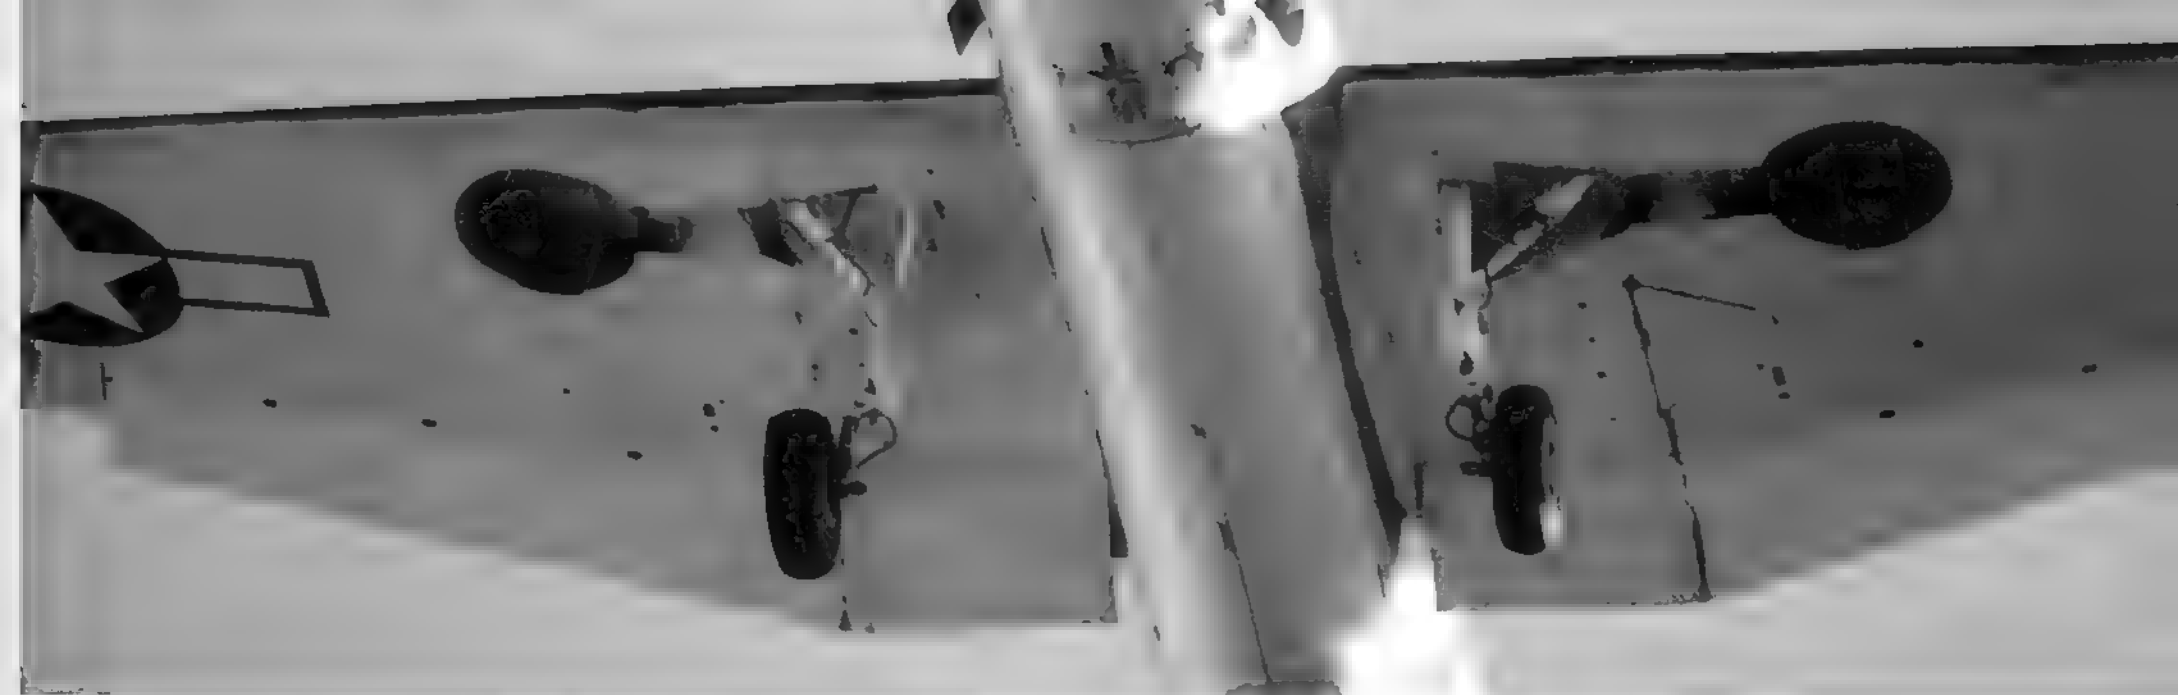
A restored TBM-3 Avenger had just taken off from Marine Corps Air Station (MCAS) El Toro, California during an air show on 27 April 1990. The main gear retracted by being pulled upward and outward into the landing gear bays placed in the outer wing sections. No doors were provided for the main gear wells in order to save weight and reduce main-

tenance requirements. The triangular doors associated with the wing folding system are folded into the outer wing sections, aft of the landing gear bays. (Ted Carlson/Fotodynamics)

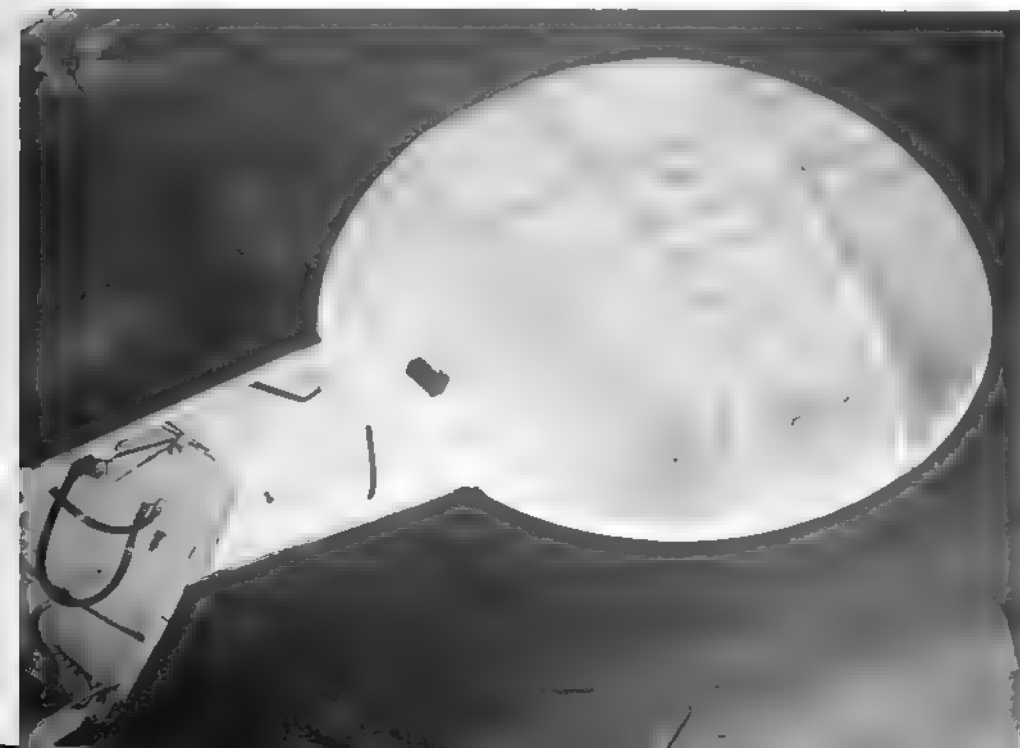
The Avenger's main landing gear well was shaped to conform to the main landing gear wheel and door assembly. The metal fore-and-aft ribs and the stringers inside the bay provided strength to the gear well structure. Black hoses in the inboard gear well area supplied hydraulic liquid to the gear retraction system. (Glen Phillips)

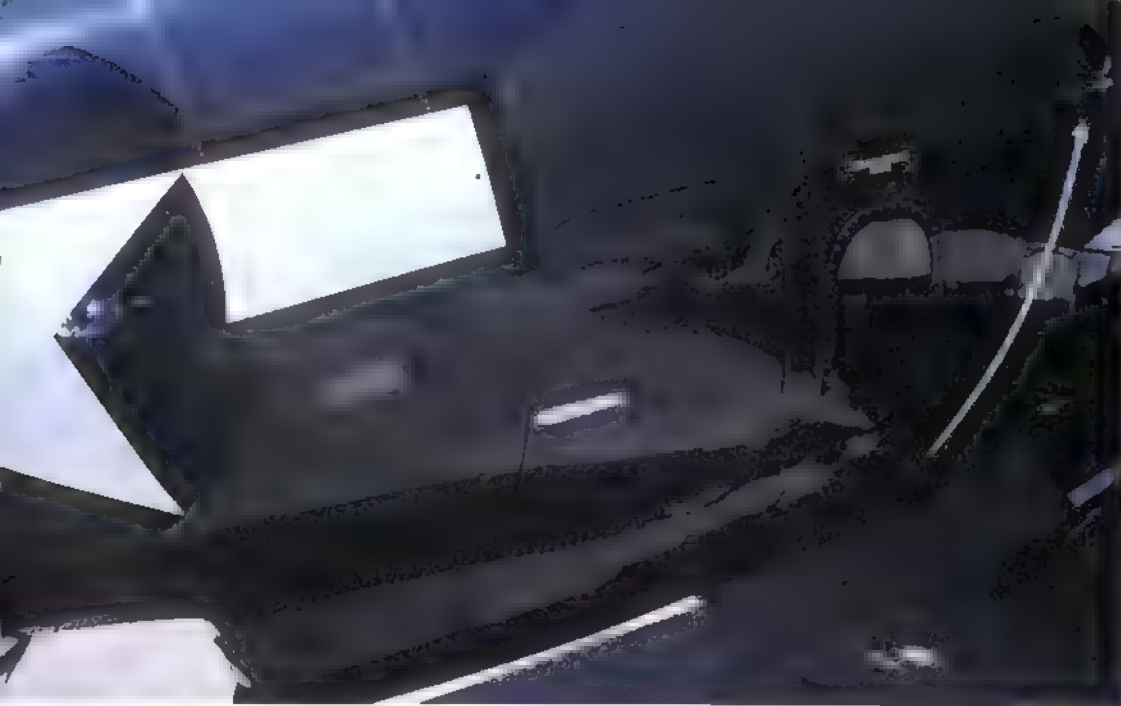
Two oval windows flank the turret gunner and radio operator/bombardier's access hatch on the Avenger's starboard rear fuselage. Identical windows were placed on the port rear fuselage. This window arrangement was standardized on late production TBF-1s and continued through the TBM-3. Avengers supplied to Britain during World War II replaced the windows nearest the wing with observation domes. (Lou Drendel)

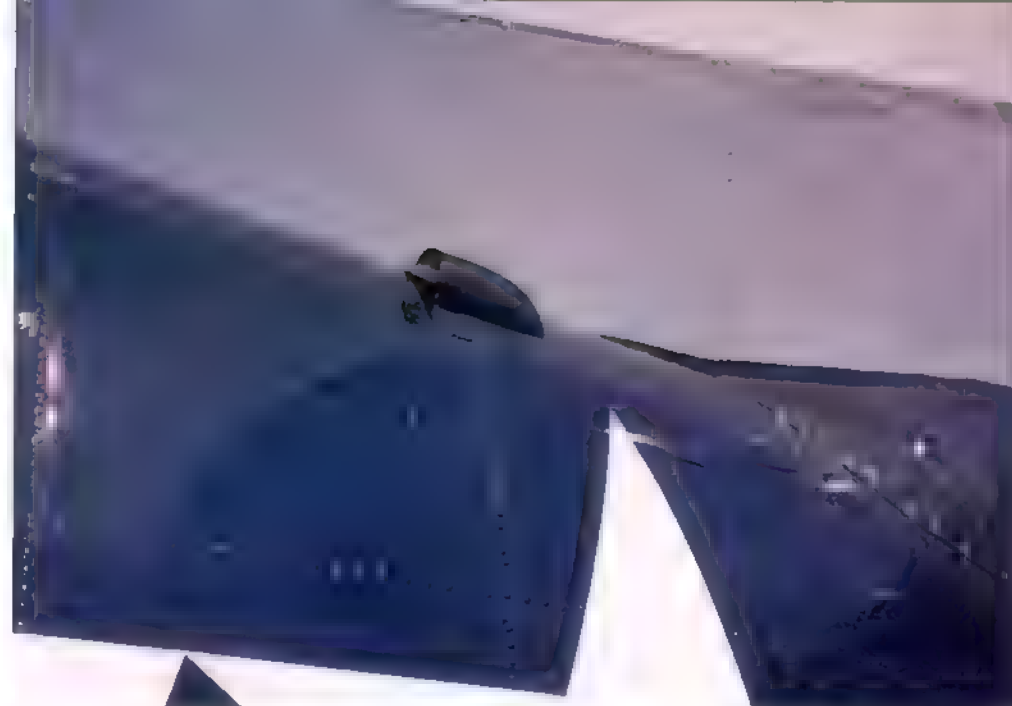
An air intake scoop was placed on the upper aft fuselage of all TBFs and TBMs, immediately port of the dorsal fin. This scoop brought fresh air into the Avenger's aft compartment. The dorsal fin aided in the aircraft's directional stability and was added to the Avenger beginning with the second XTBF-1 prototype. (Lou Drendel)

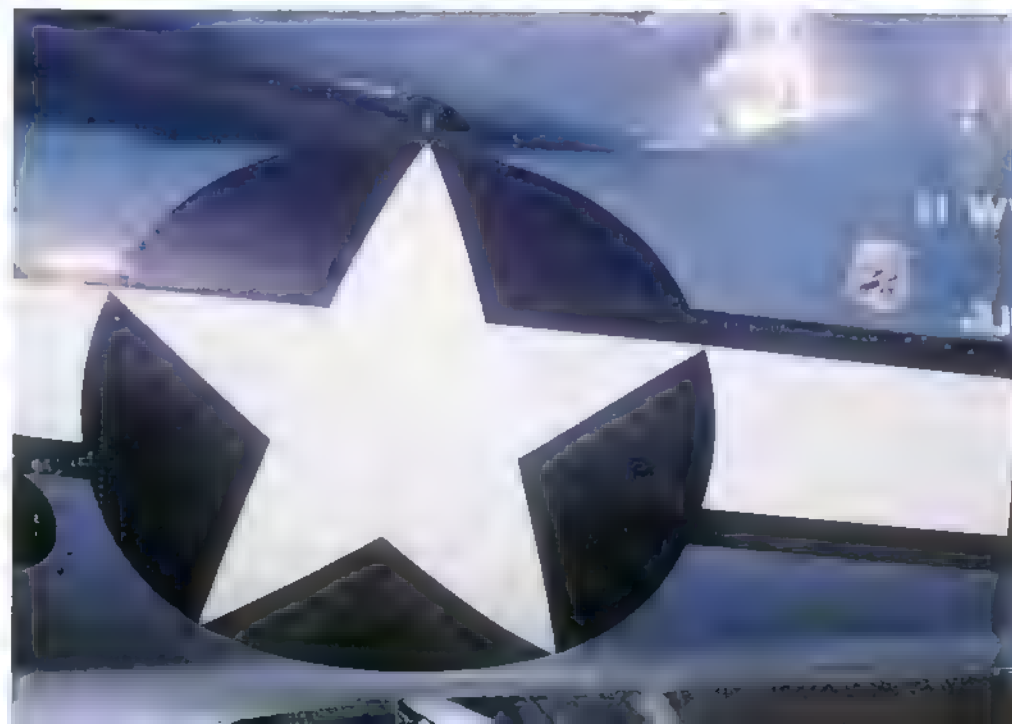
The national insignia applied to this restored Avenger is incorrect in both dimension and detail. The white star points should not go all the way to the edge of the blue circle. The lifting tube's port side opening is located within the rear quadrant of the national insignia. A metal bar was placed within the lifting tube to jack up the TBF/TBM's aft fuselage for aircraft maintenance. (Lou Drendel)

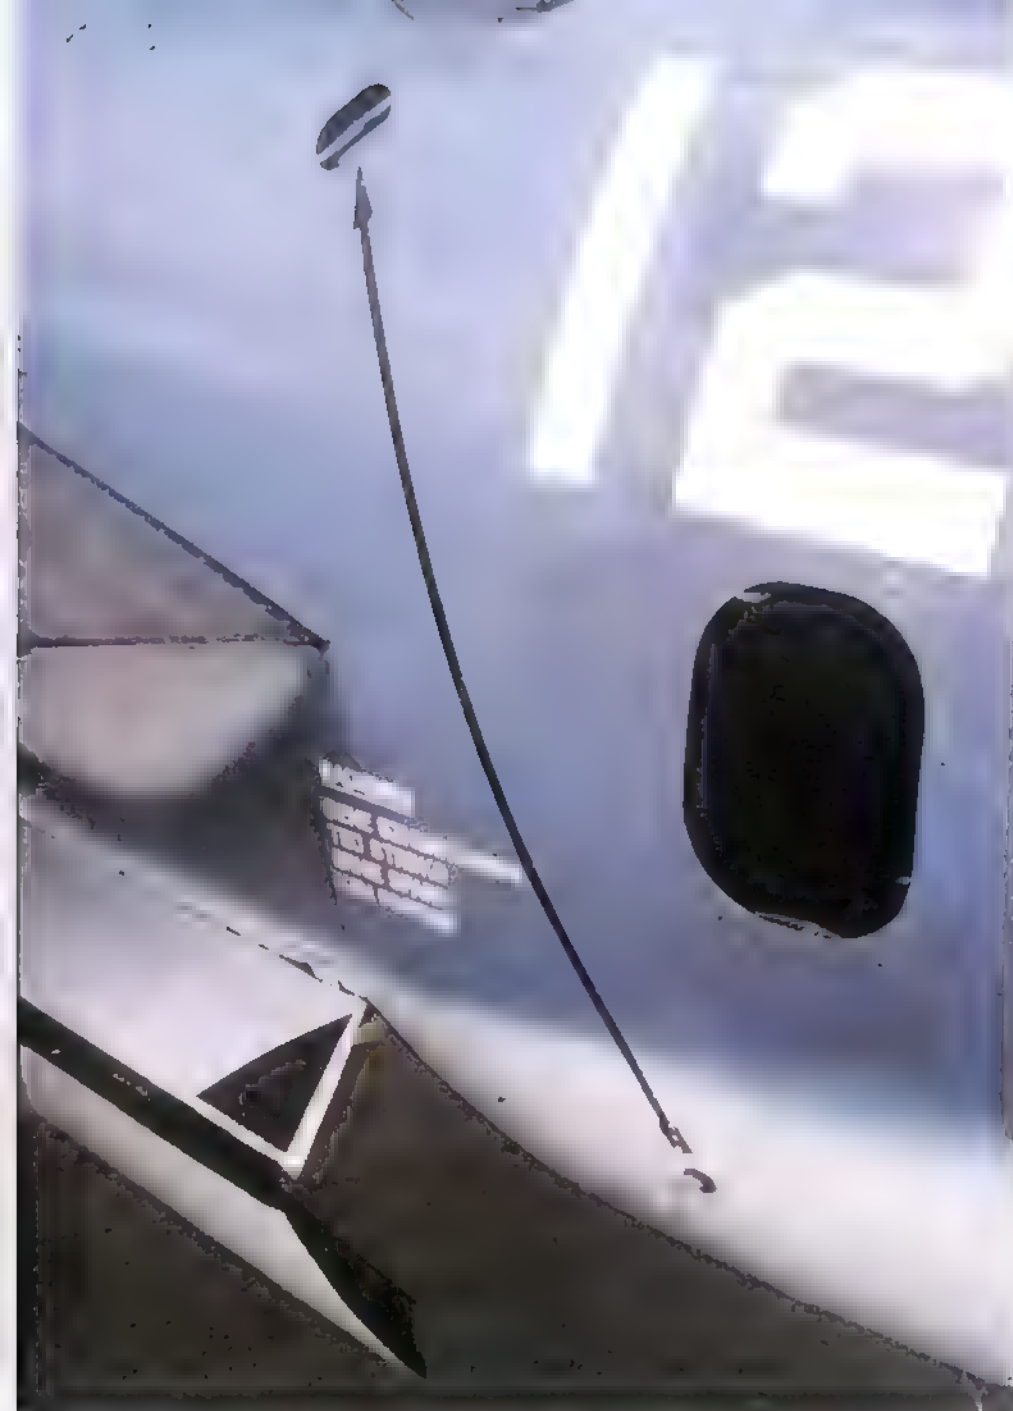
This restored TBM has a short extended step fitted instead of the usual flush-mounted kickstep on the port aft fuselage, below the forward radio compartment window. Crewmen used the step and the handhold up the fuselage side to aid in climbing onto the Avenger's wing root. This arrangement also existed on the aircraft's starboard side. The area between the step and the handhold was usually marked with an upward pointing arrow: black for light colored finishes, or white for dark colored schemes. (Lou Drendel)

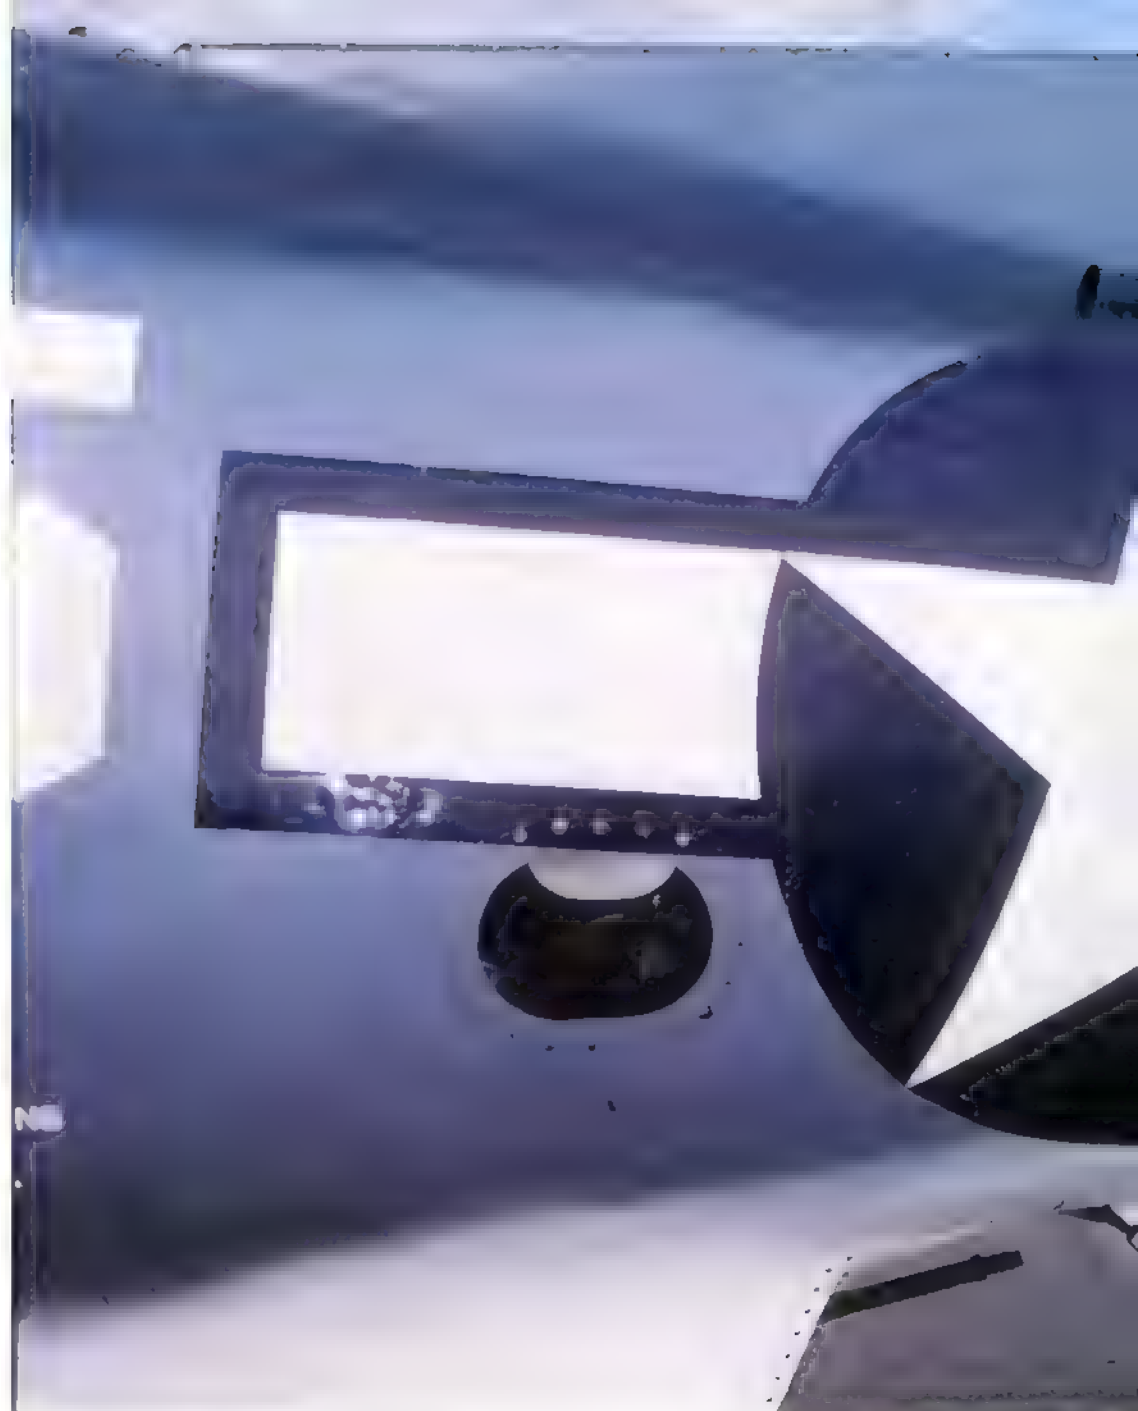
This restored TBM-3E does not have the ventral gun tunnel windows used on earlier Avenger models. The last production model deleted the ventral .30 caliber (7.62mm) Colt-Browning M2 machine gun and the windows associated with this position to save weight and increase airframe strength. The restorers did install a window and simulated machine gun at the tunnel's aft end. All TBF and TBM windows were made from Plexiglas, except for the turret gunner's bulletproof shield. (Lou Drendel)

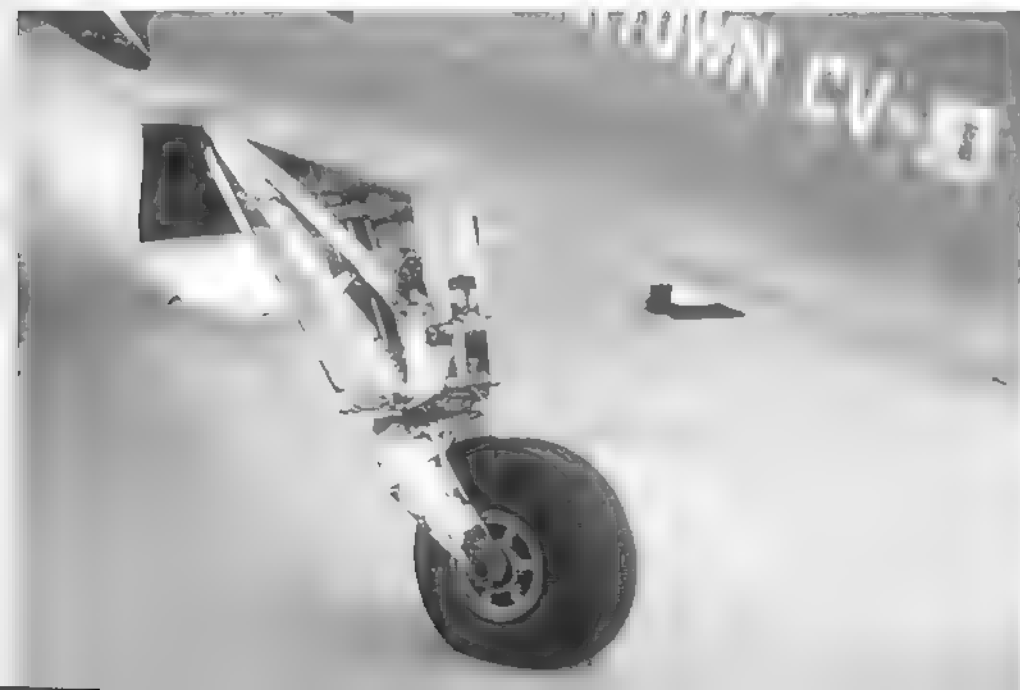
The Avenger's tail wheel was fully retractable, which allowed a clear field of fire for the ventral machine gun. Land-based TBFs and TBMs used a Firestone pneumatic tire, measuring 14.5 inches (36.8 cm) in diameter by five inches (12.7 cm) wide. This tire was inflated to 95 pounds (43.1 kg) per square inch. Carrier-based aircraft used a solid rubber Grizzly tail wheel of the same size. (Glen Phillips)

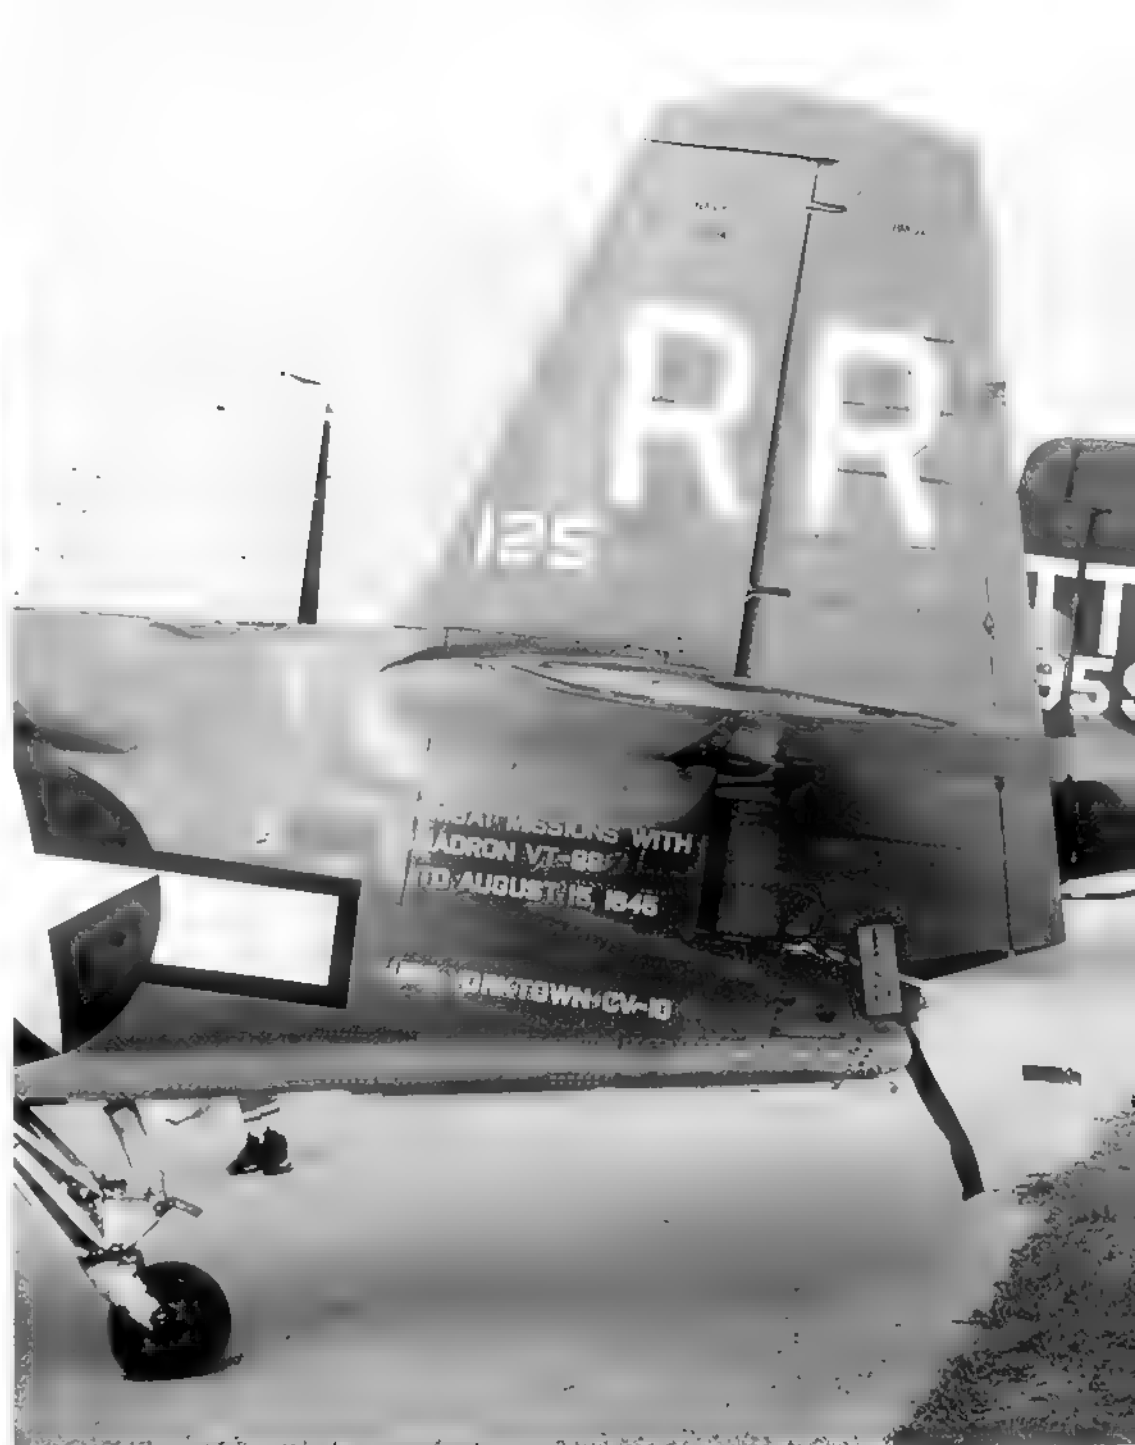
Coke Stuart's TBM-3E (RR-125, BuNo 85794) was finished in the colors it wore when it flew combat missions from the USS YORKTOWN (CV-10) in the summer of 1945. This Avenger flew 11 combat missions while assigned to Torpedo Squadron 88 (VT-88) aboard the YORKTOWN. The aircraft was fitted with the retractable arresting hook, which was replaced with the external hook on late production TBM-3Es. (Lou Drendel)

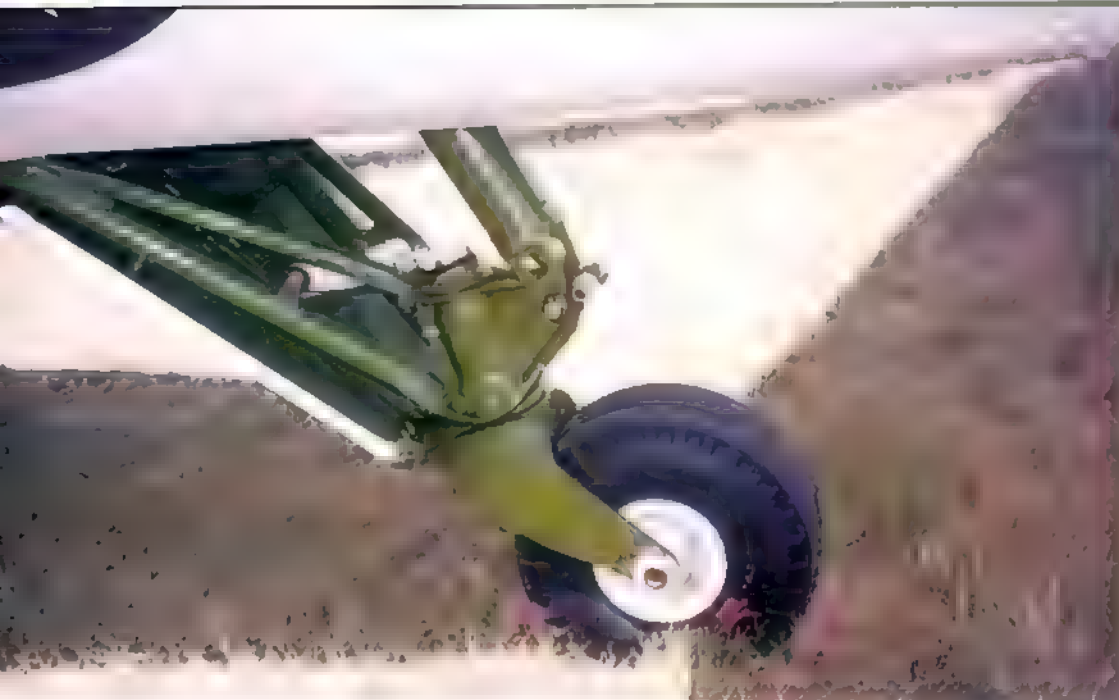
The TBM tail landing gear consisted of a self-aligning, full swivel type tail wheel with a controllable non-swivel lock mechanism, a Bendix Pneudraulic (pneumatic and hydraulic) shock strut, and a tire and wheel assembly. The white bracket above the tire was the fitting for the hold back cable used when catapulting the Avenger from a carrier. The landing gear strut and door inner surface – finished Bronze Green on this example – was painted on service aircraft to match the Avenger's undersurface color. (Lou Drendel)

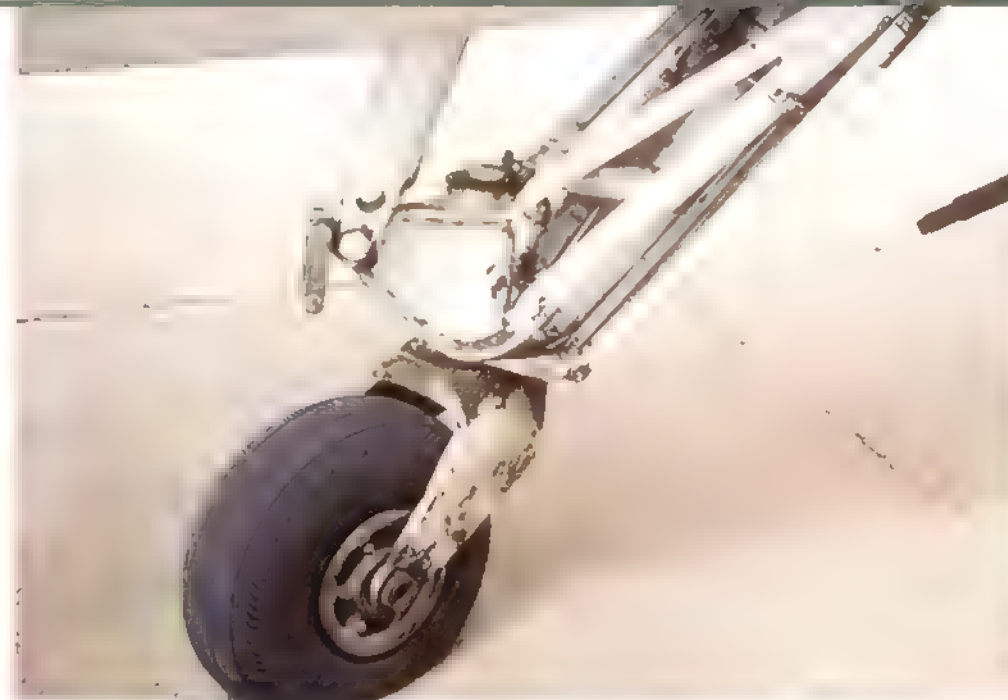
The tail landing gear included a two-pronged drag strut mounted beside the gear door, with a centering unit placed above the drag strut. These struts and the Bendix shock strut mounted aft were connected to the castor assembly in which the tail wheel was mounted. The shock strut pulls the tail landing gear fully up into the aft fuselage on retraction. The tail gear door covered only the landing gear strut, not the tail wheel. (Glen Phillips)

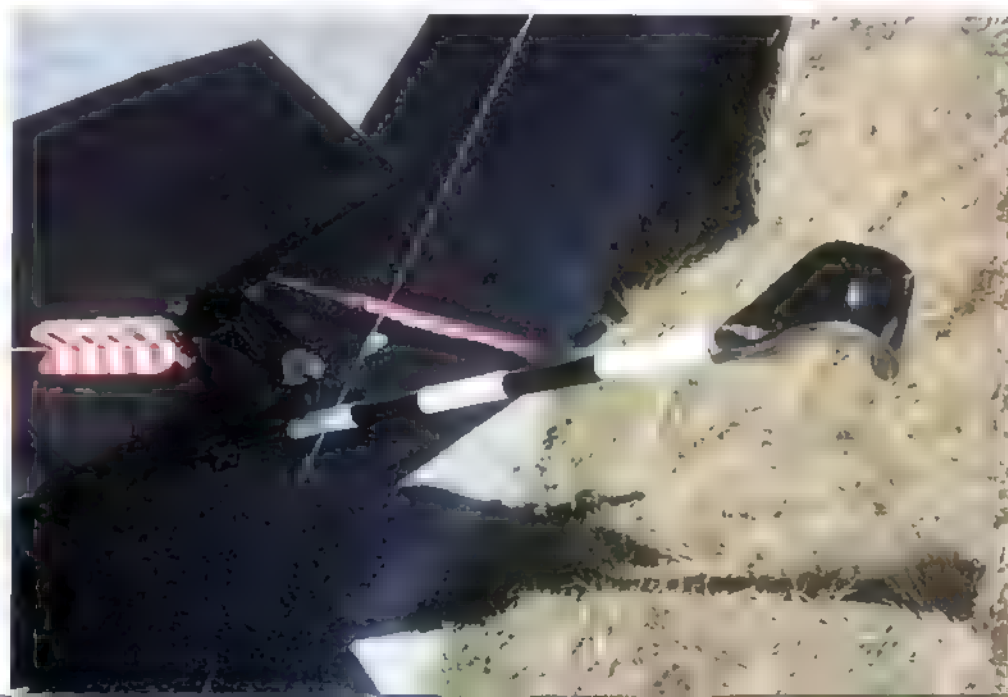
The tail hooks on US Navy carrier-based aircraft were usually striped black and white to improve their visibility for deck crews. A white navigation light was mounted immediately above the tail hook. This light enabled other pilots to determine the aircraft's position at night. A red and white control lock placed at the rudder's base prevented the rudder from moving freely in the wind while parked. (Lou Drendel)

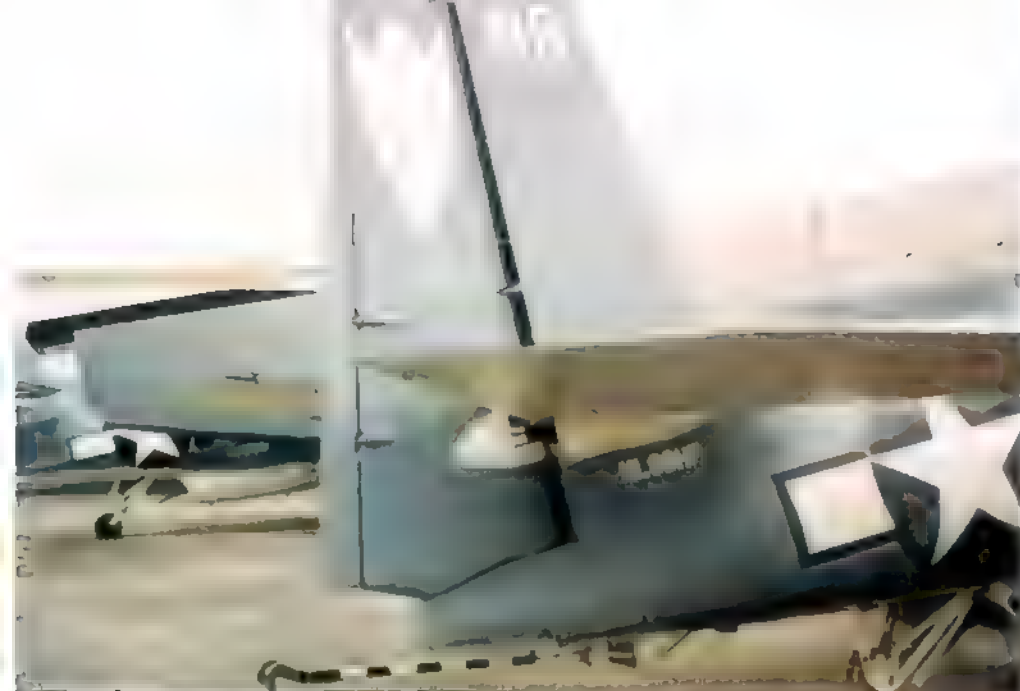
This restored TBM-3E (BuNo 53522, NL88HP) displays a white arrowhead on the rudder. This insignia was applied to Avengers assigned to Composite Squadron 8 (VC-8) aboard the USS NEHENTA BAY (CVE-74) in early 1945. The Avenger and most other World War II-era aircraft had fabric rudders, elevators, and ailerons. The TBM's rudder had a range of 24' to either port or starboard. The white area under the horizontal stabilizer's base provided counter shading as part of the camouflage scheme. (Walt Houghton)

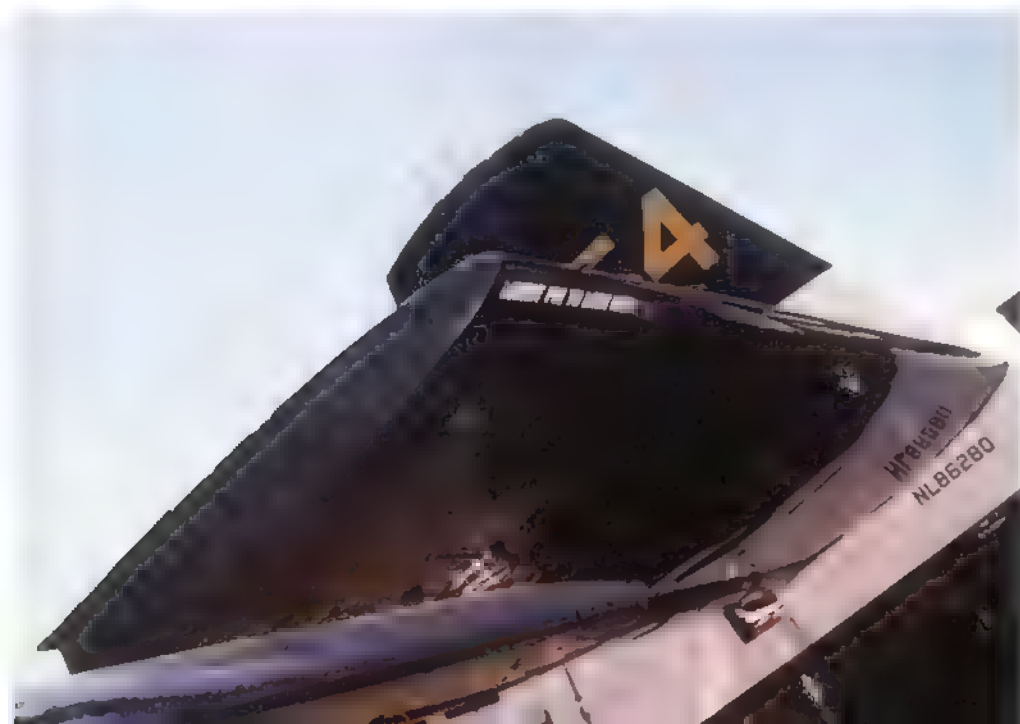
The inscription INSERT PIN TO LOCK WING on the horizontal stabilizer's leading edge referred to the ability to lock the folded wing against the stabilizer to prevent wind damage. Immediately above this inscription was the tie-back cable anchor point. The Avenger's elevators had a movement range from +20' to -10'. (Lou Drendel)

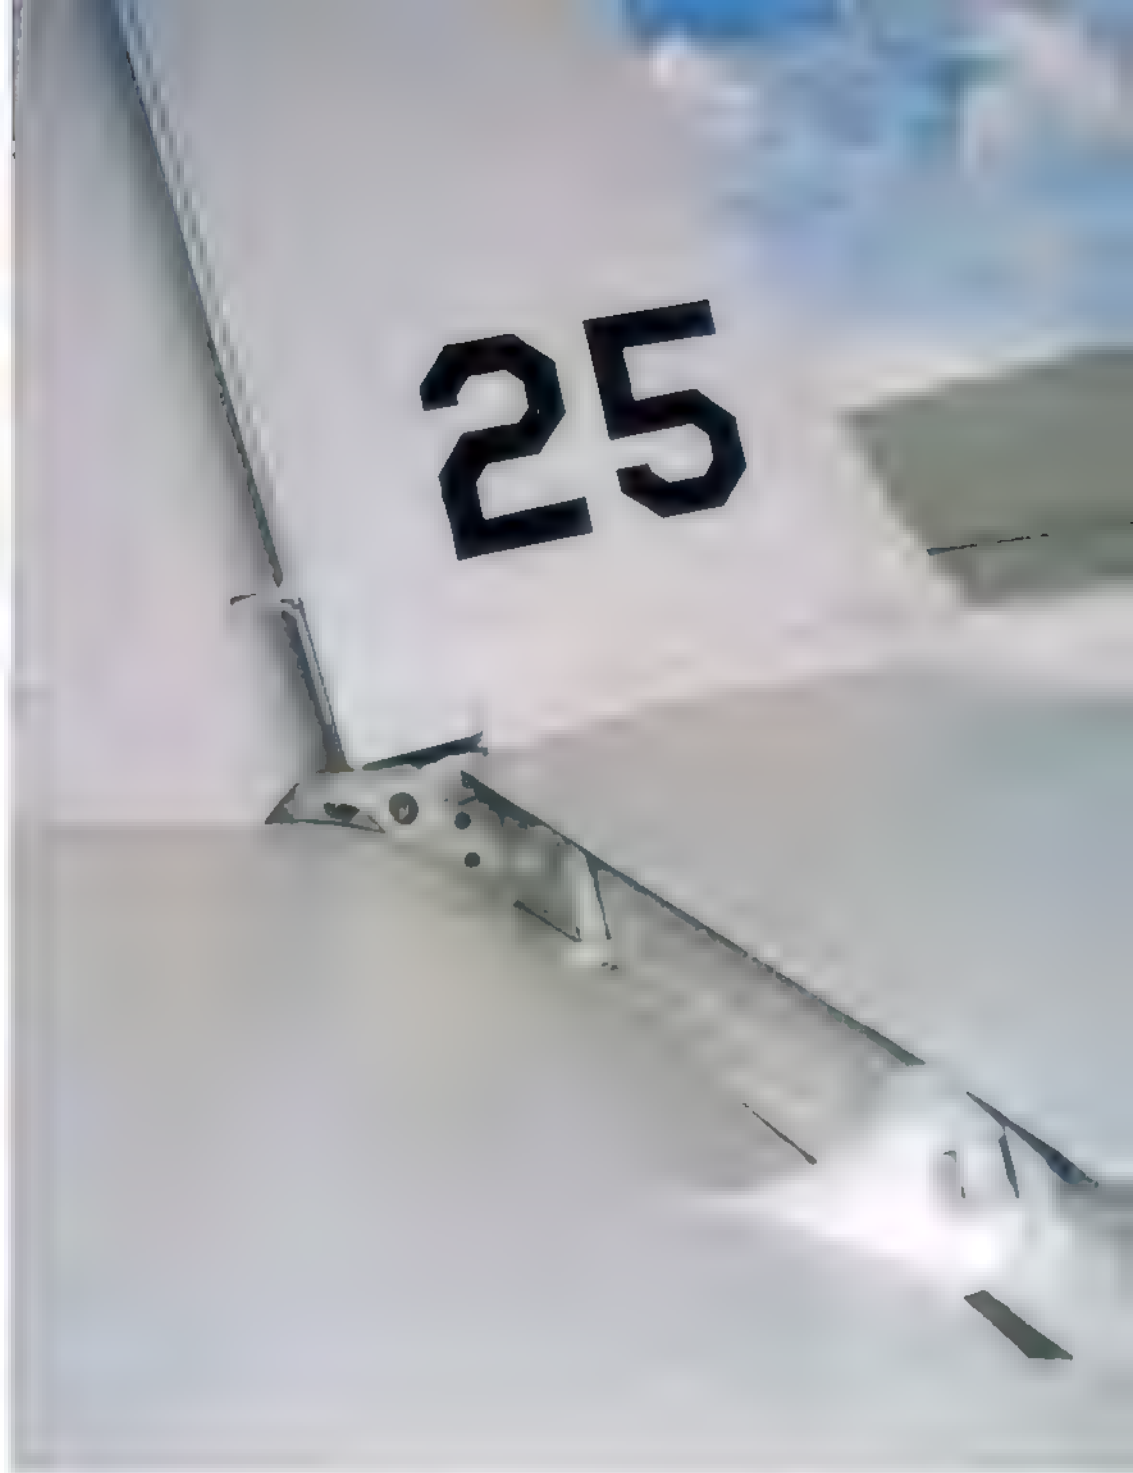
Each elevator was fitted with two hinges mounted on the elevator spar. These hinges were attached to the elevator spar and rotated on brackets fitted to the horizontal stabilizer. The elevator control unit was placed between the horizontal stabilizers' root. The horizontal stabilizer skins were aluminum alloy, while the elevator was fabric covered. (Lou Drendel)

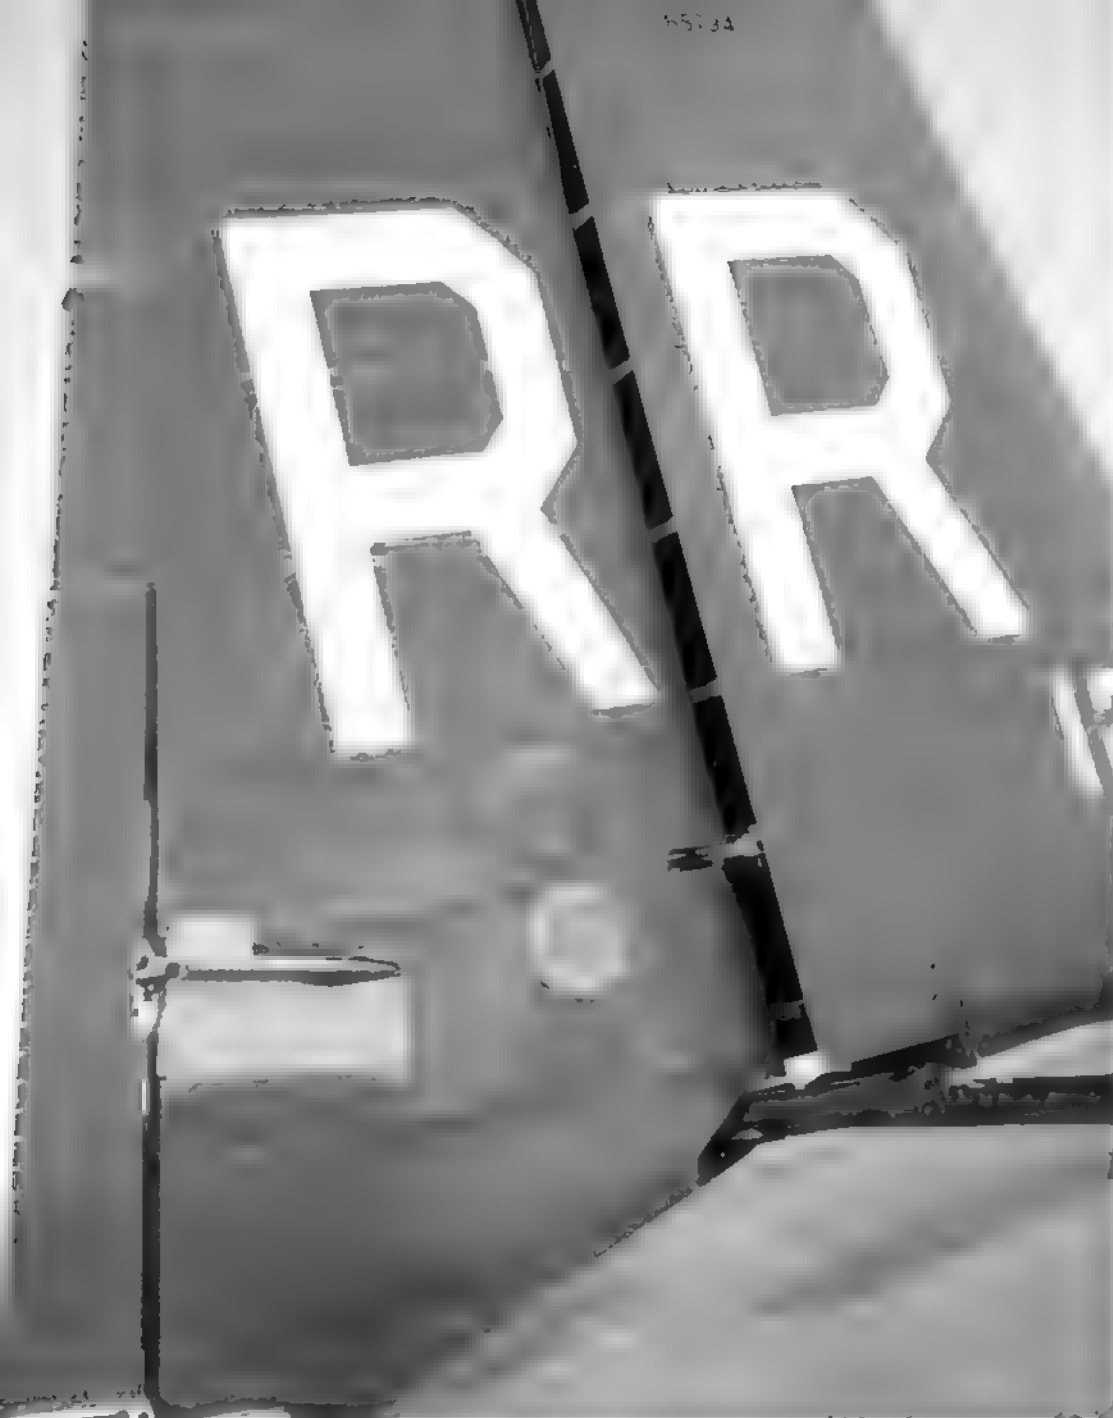
One of the advantages of fabric covered control surfaces is the ability to repair holes with duct tape! The tape repaired a hole immediately under the rudder servo tab horn. This horn and the horn for the trim tab immediately below were only on the rudder's starboard side. Control horns provided aerodynamic force to aid in the deflection of the tabs. This aircraft is the combat veteran TBM-3E (RR-125, BuNo 85794), owned by Coke Stuart. (Lou Drendel)

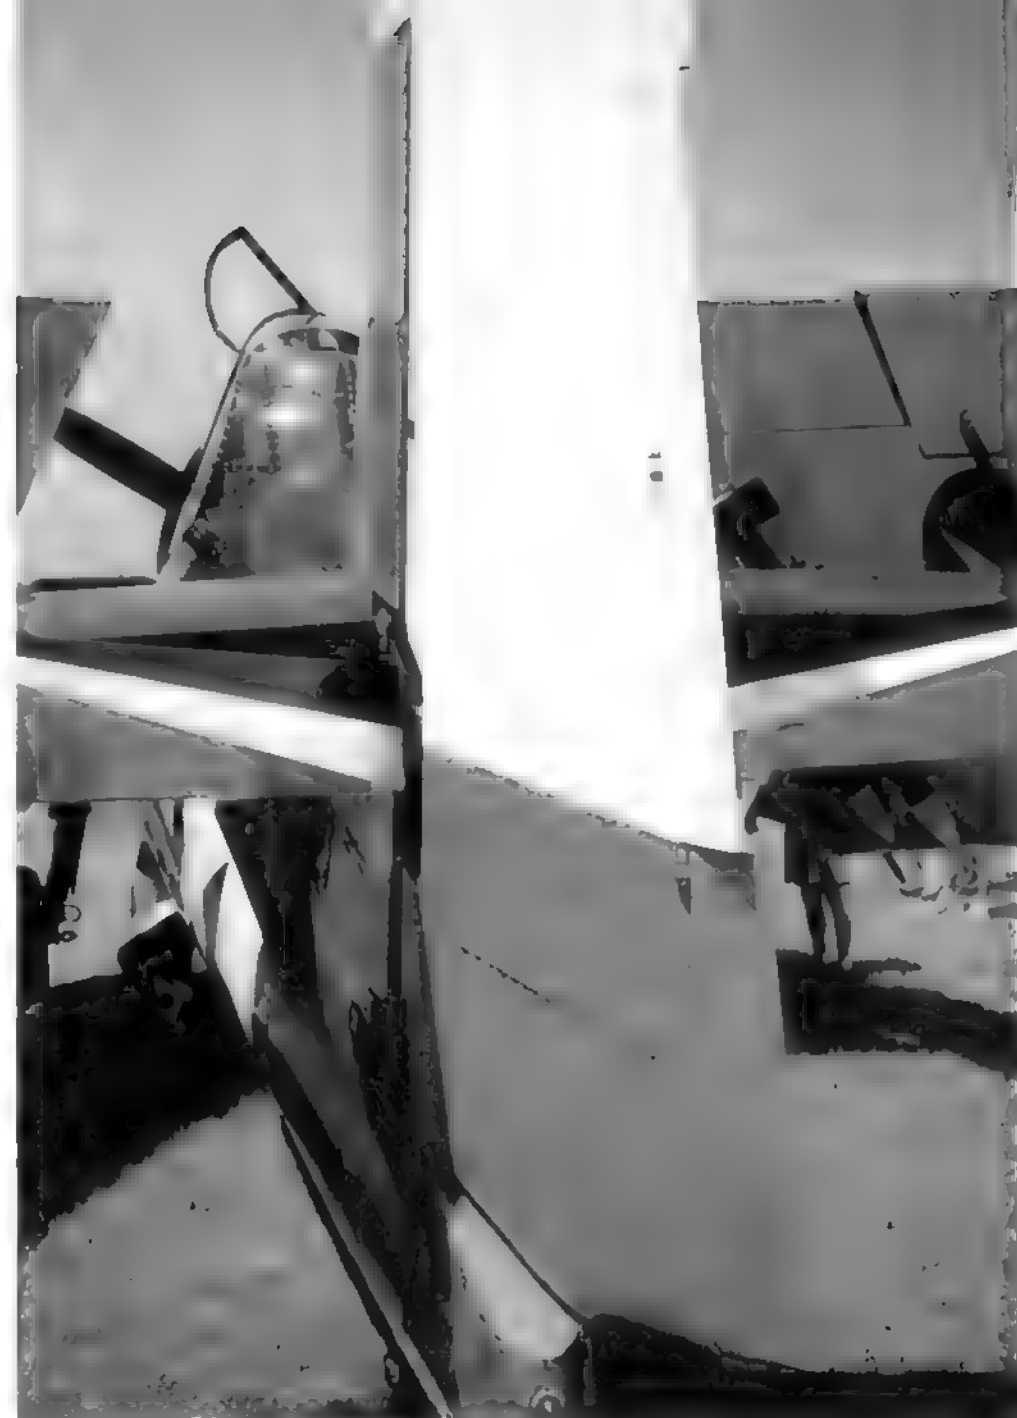
Avengers were equipped with aluminum split rudder tabs. The servo tab at the top generated the aerodynamic force required for moving the rudder port or starboard. The trim tab immediately below the servo tab was used to counteract aerodynamic forces. This trim tab moved opposite the direction of rudder deflection and served to 'boost' the rudder, easing its use for the pilot. (Lou Drendel)

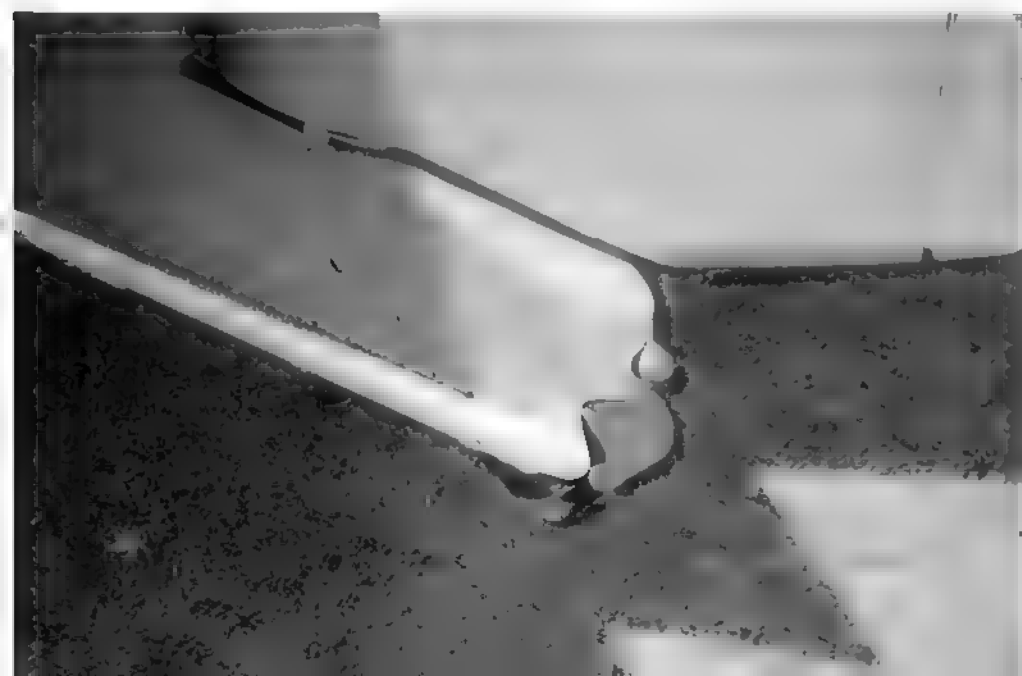
The rounded leading edge of the rudder allowed for ease of movement when deflected to either port or starboard. The tab flex shaft running from the vertical stabilizer's base carried input from the pilot's rudder trim controls to the trim tabs. The rudder control cable ran along a grooved wheel at the rudder's base and through the vertical stabilizer. A red and white striped rudder lock was installed on this parked Avenger. (Lou Drendel)

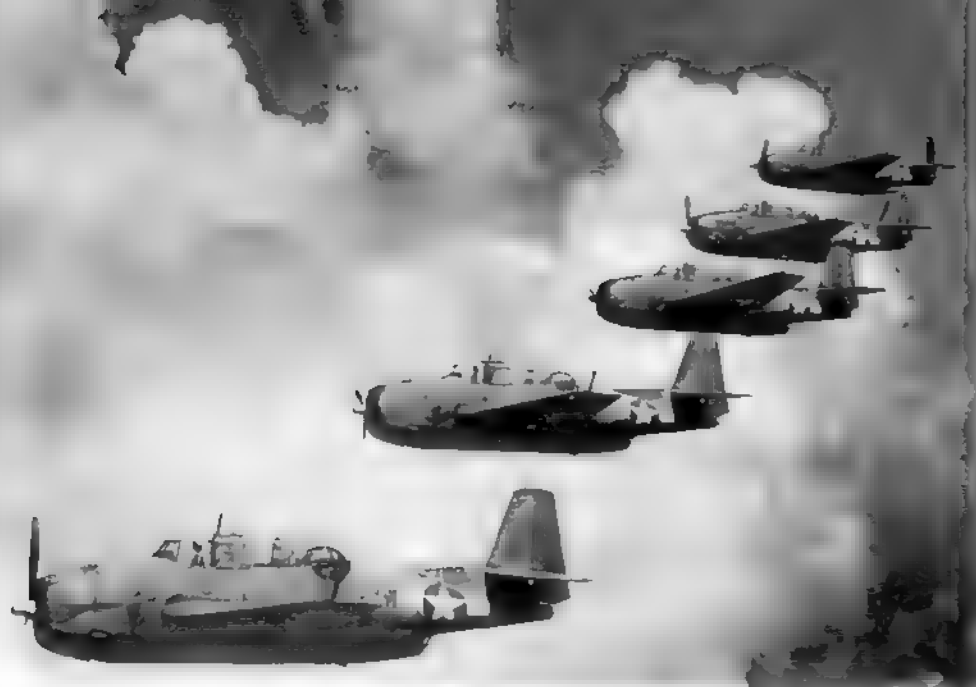
A stepped echelon formation of five TBF-1s, led by F-T 48, fly a training mission in mid-1943. The Avengers were finished in the Blue-Gray over Light Gray camouflage scheme, with the short-lived national insignia with red trim. US personnel in the Pacific felt the red trim could be mistaken in a flash for the Japanese red *Hinomaru* (rising sun) emblem. TBF/TBM pilots often flew their aircraft with their canopies open, exposing themselves to the breeze. (US Navy via Norman E. Taylor)

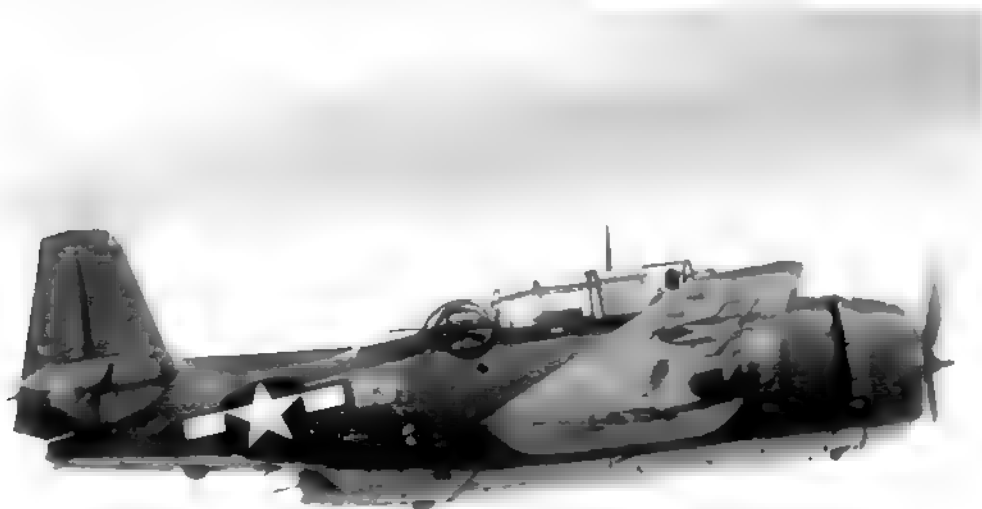
TBM-3, White 113, flies past medium altitude clouds while on a mission. The TBM-3 was the most heavily produced Avenger model, with 4664 examples produced from the spring of 1944 until the summer of 1945. This model featured the more powerful 1900 HP R-2600-20 engine, Mark 5 zero length rocket launchers, and improved cockpit lighting. The Eastern Aircraft Division of General Motors built all TBMs at their five plants in New Jersey, New York, and Maryland. (Norman E. Taylor Collection.)
